Head-Aches No More

Figure 1: The working parts of a marine sanitation device (Raritan PH-II).

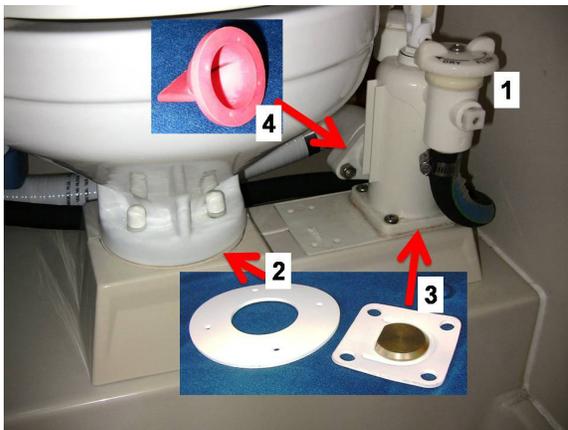
1: Seawater intake valve controls the inflow of seawater for purposes of flushing.
2: Main seal at base of bowl. Similar in function to wax ring in domestic toilets.
3: Flapper valve controls evacuation of bowl and stops backflow.
4: Joker valve allows one-way flow of waste into plumbing hoses.
Marine heads of this type will have similar components and operation as discussed here for the Raritan head.

- 1) Most traditional heads depend on **water to lubricate all components** and to assure an uneventful emptying of the bowl. Make sure the intake seacock and the head-mounted valve (see location #1 in Figure 1) are both open and the head is primed with 2-3 pump strokes of water. It will be too late 'afterwards'. No water coming in? Stop right there and speak to someone with more experience (for brevity referred to as 'SRTASTSWME')

- 1) Symptom: **No water coming into the bowl** when the pump handle is pulled upward after a few strokes. After SRTASTSWME, the conclusions might be a) one of the intake valves isn't open (99% case); or b) the intake is clogged or obstructed on the outside (<1% case). Both issues are easily resolved. Other intake-valve-related problems (#1 in Figure 1) are extremely rare.

- 2) Symptom: Water pumps into the bowl with every upstroke but **nothing is evacuated at the bottom**, thus leading to gradual filling of the bowl (SRTASTSWME!). This describes our recent character-building experience. Since the top part of the pump is obviously working fine, the problem is in the lower part. Component #2 is the main seal upon which the bowl rests. The critical component that failed in this scenario is the flapper valve (#3) at the bottom of the pump assembly. We had a case of 'dry flush' (remember that from the Bareboat Test?) which clogged the entire drain line between main seal #2 and the flapper valve #3 at the bottom of the pump. The only remedy is removal of pump from its base and clearing of the obstruction bowl-side of the flapper. Despite the initial shudder, the feeling of accomplishment should be rewarding enough!

- 3) Symptom: Water pumps into the bowl with every upstroke and **waste is pumped out of bowl but returns on next downward stroke**. The culprit? Could it be the joker? On first thought, it can't be 1) or 2) with some level of certainty. The joker valve (#4), a rubber half-sphere with a narrow slit, separates the output of the pump from the downstream plumbing lines. If the slit remains open (perhaps due to a hair ball, Band-Aids or even-more exotic things) the pump re-cycles waste from the plumbing lines, squeezing it through the flapper valve (#3) and back into the bowl. Another case of SRTASTSWME! Removal and cleaning of the joker valve usually exceeds the endurance of most charterers. The valve itself is usually quite 'clean' but the same can't be said about the backflow from the plumbing lines. Nonetheless, armed with a few paper towels, a tray and proper personal protection this, too, is solvable and leads to a deeper appreciation of the system as a whole.
